# DEEPSEA YANTAI

## DROPS INSPECTION PICTURE LOG

August 2023 | AXESS PROJECT NO 258034-16 | PO: TBA

| Subject:<br>Deepsea Yantai DROPS Inspection Picture log 2023 | | | |

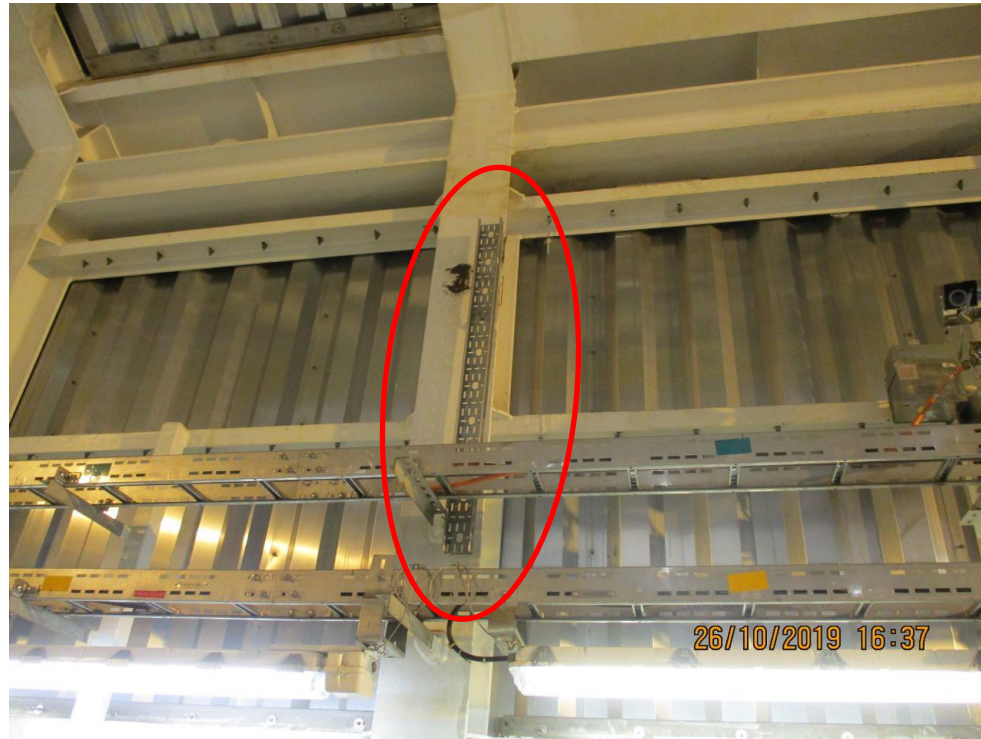
**Finding:** 1.1

**Class:** 4

Draw-works hangar, starboard side.

Redundant cable tray.

Remove, if not required.

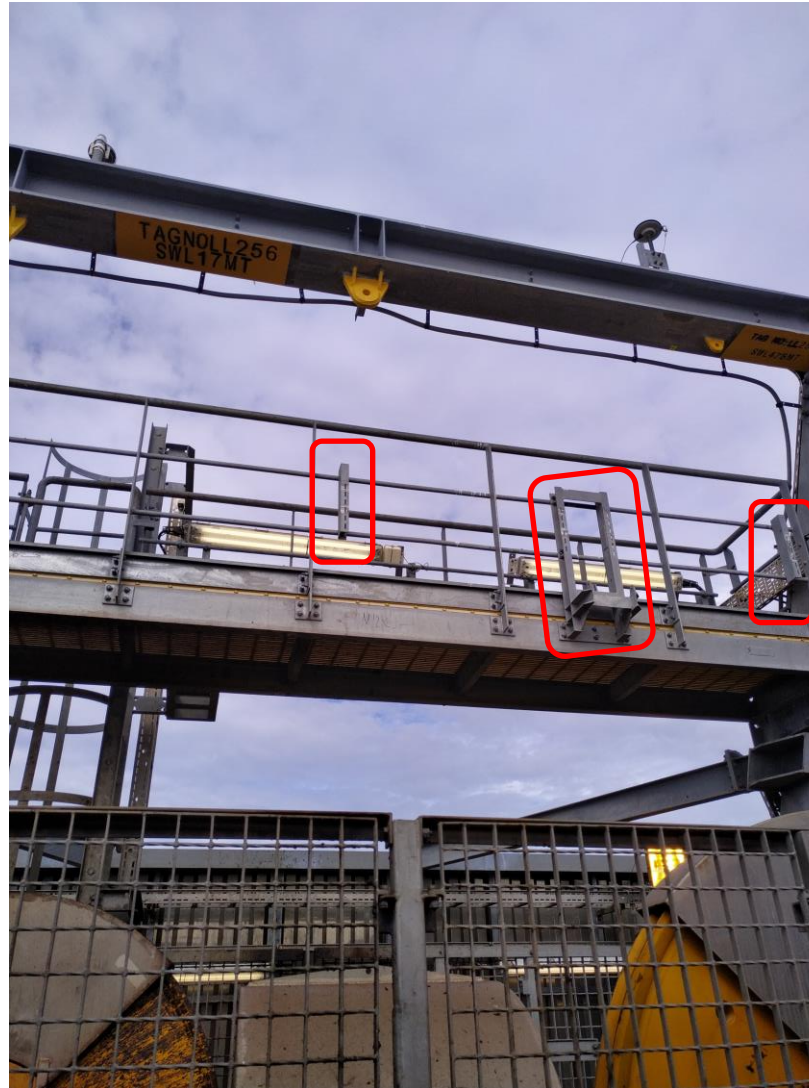
**Finding:** 1.2

**Class:** 4

Top of derrick

Redundant brackets

Remove, if not required.

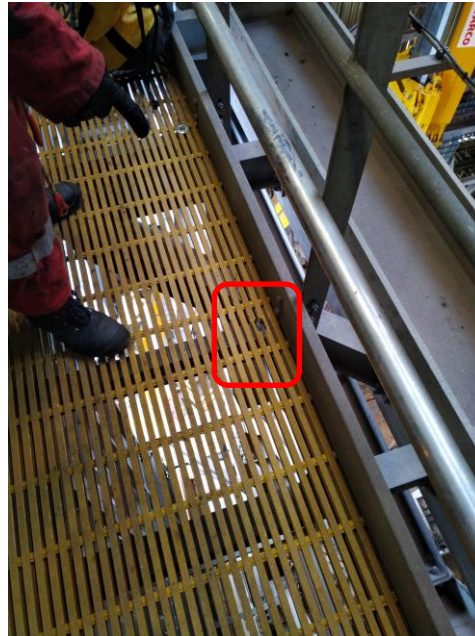
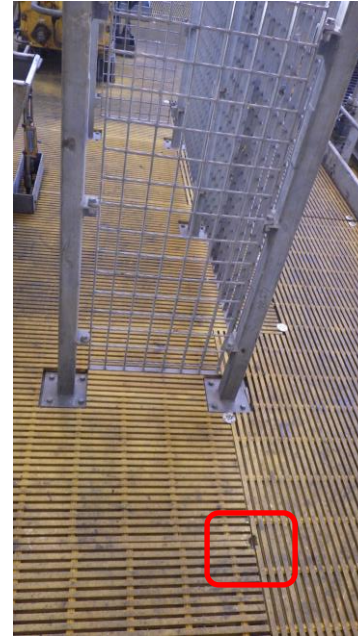
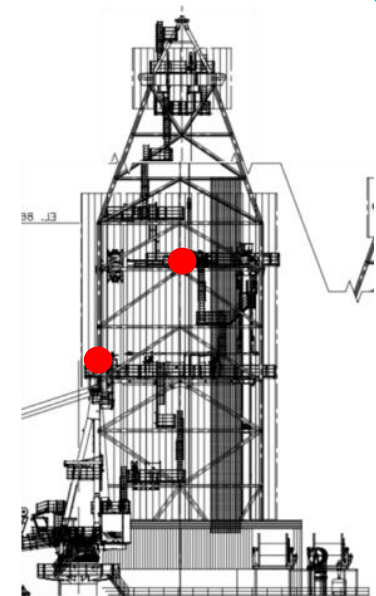
**Finding:** 1.3

**Class:** 4

Walkway aft on fingerboard level

Missing grating clips.

Install missing grating clips

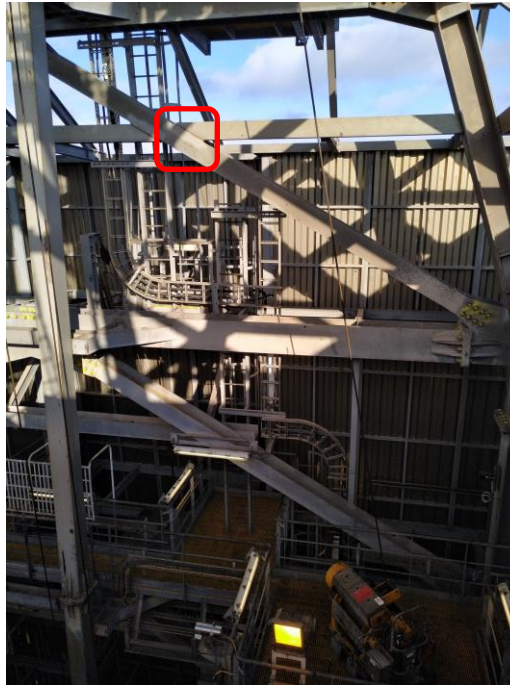
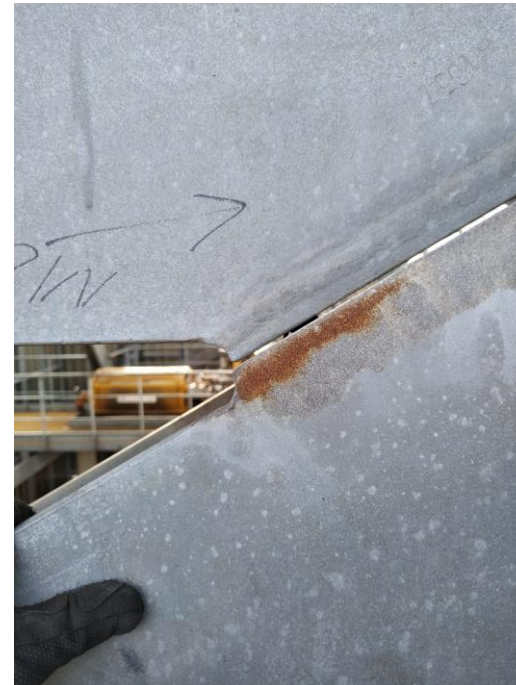
**Finding:** 1.6

**Class:** 4

Derrick stb side over winch platform.

Gap between bolted connection on structure.

Shims between connection should be used

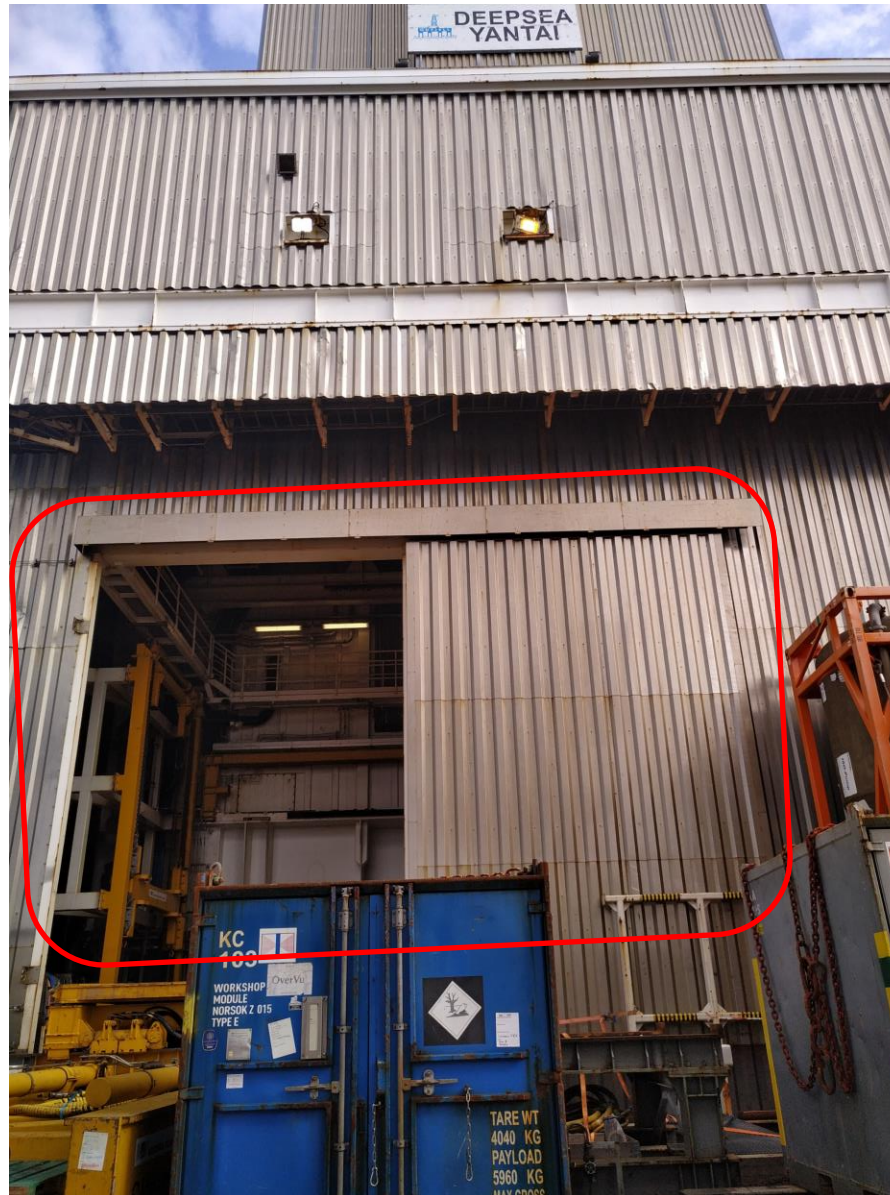
**Finding:** 1.7

**Class:** 3

Stb side of derrick below drillfloor

Loose bolts on wind walls behind door for moonpool and on aft side of door.

Retighten bolts

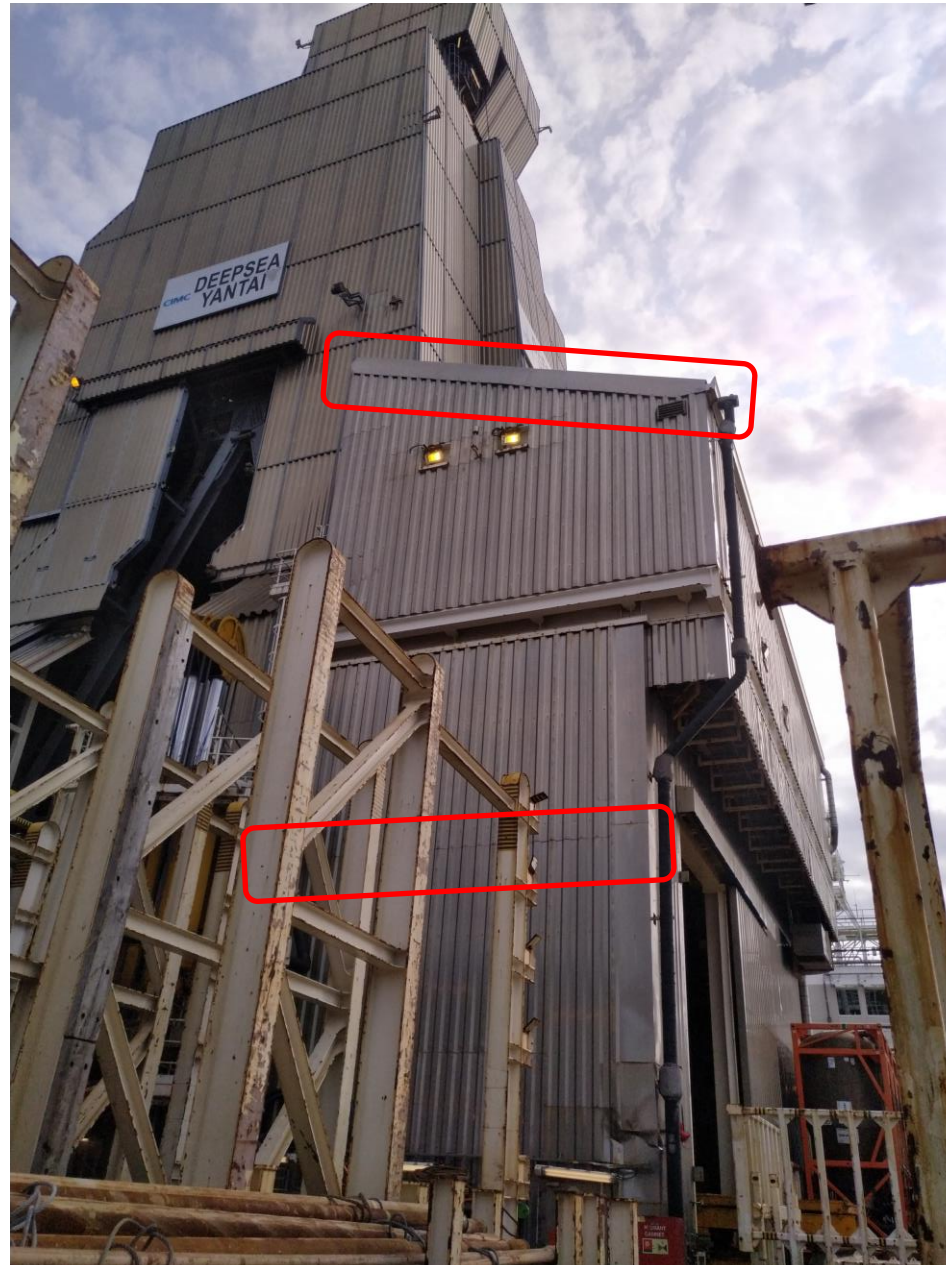
**Finding:** 1.8

**Class:** 3

Aft stb side of derrick.

Loose and missing bolts on wind wall.

Install new bolts (M6 and M8) and retighten loose bolts.

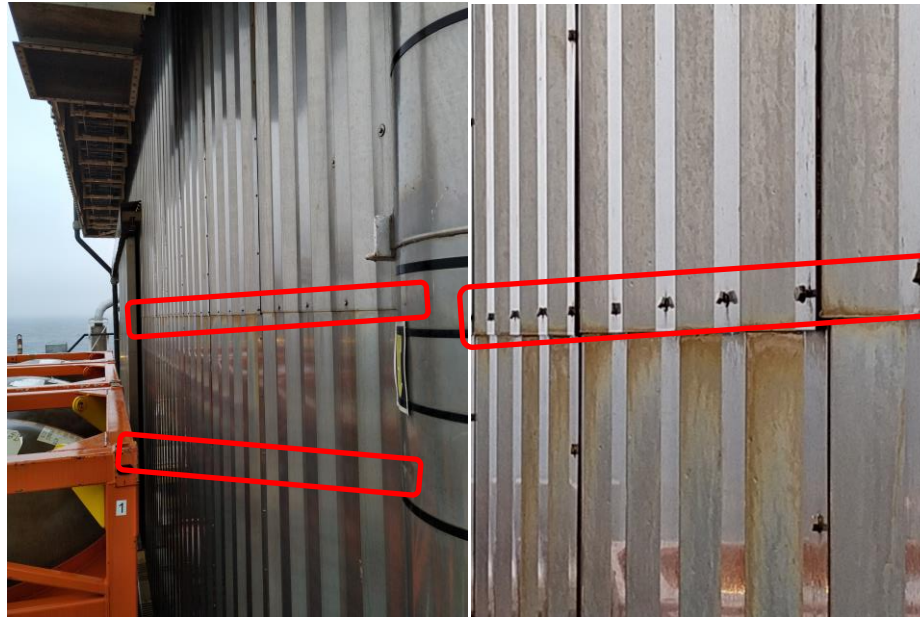
**Finding:** 1.9

**Class:** 3

Stb fwd. side of derrick below drillfloor

Loose bolts on wind walls

Retighten bolts

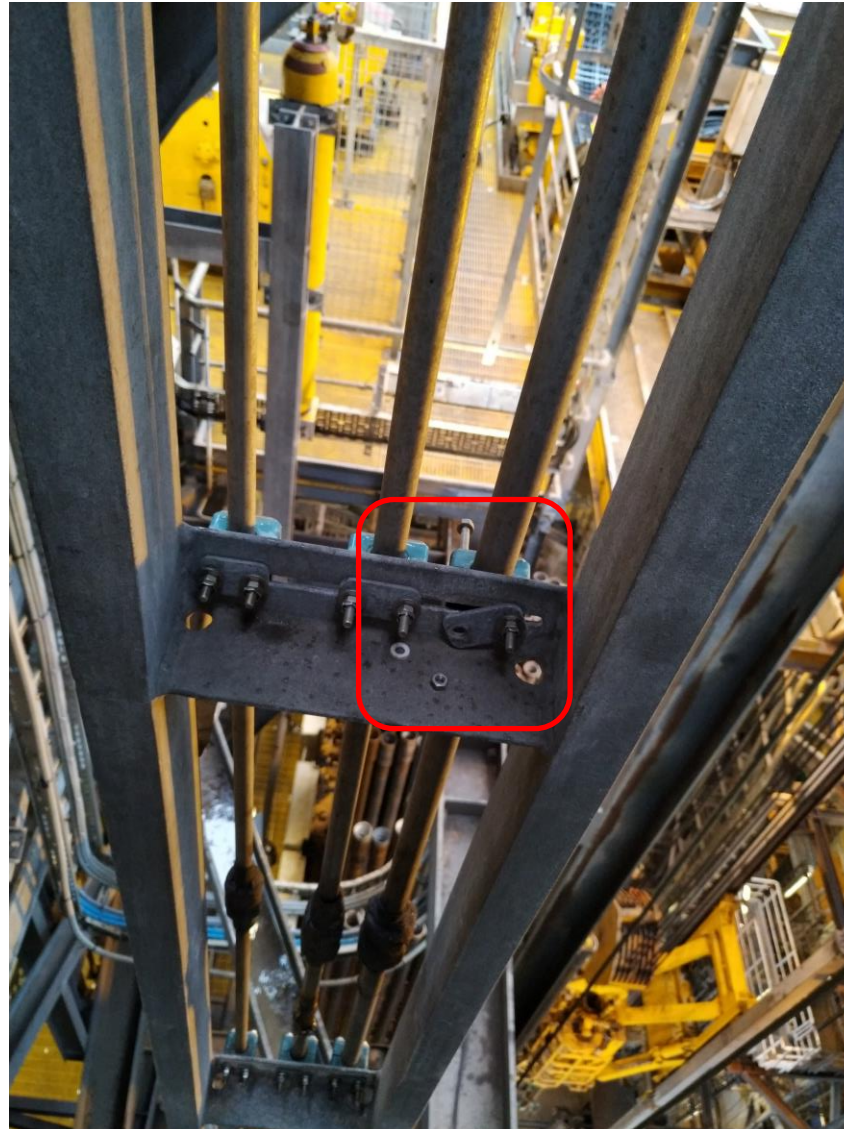
**Finding:** 1.11

**Class:** 1

**Location:**  
Derrick.

**Description:**  
Loose bolts on pipe brackets

Loose bolts have been removed.

Install new bolt.

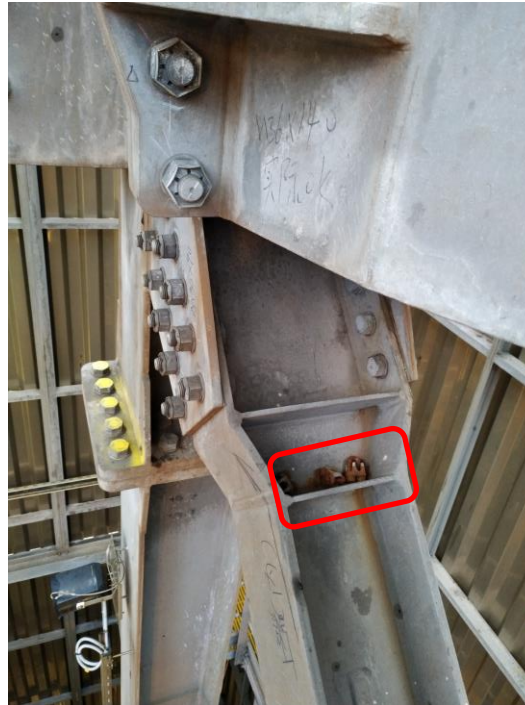
**Finding:** 1.12

**Class:** 1

**Location:**  
Derrick.

Equipment left at height.

Remove equipment.

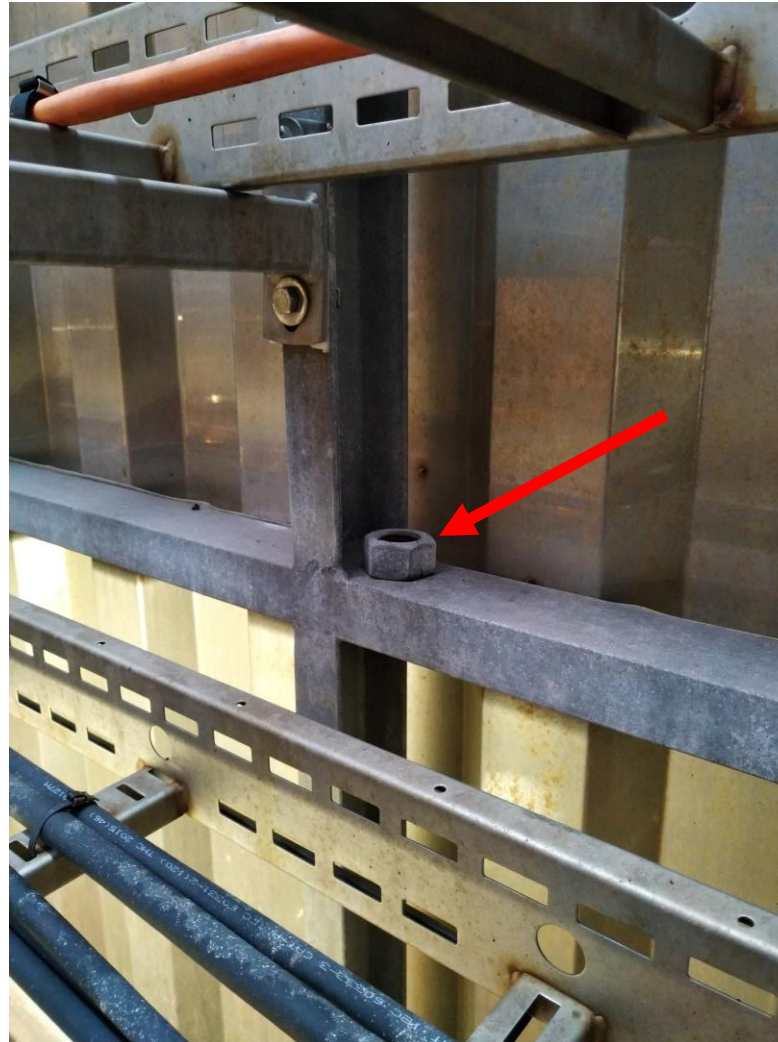
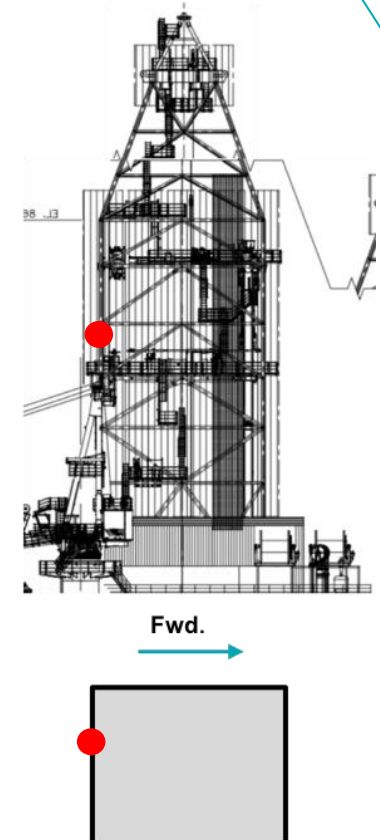
**Finding:** 1.13

**Class:** 1

Derrick aft, over fingerboard level

Equipment left at height.

Remove equipment.

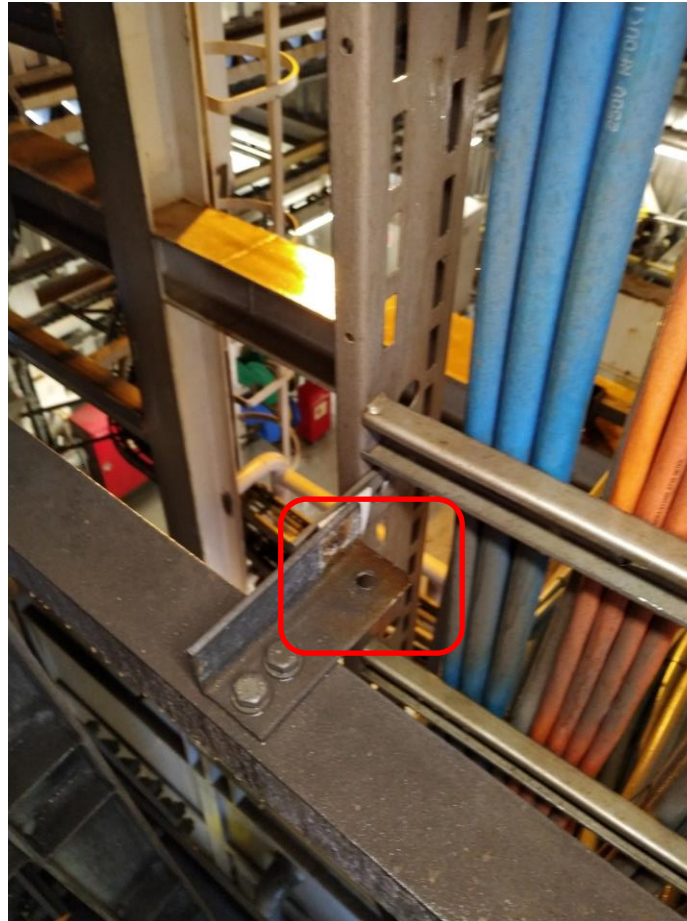
**Finding:** 1.14

**Class:** 3

Derrick

Missing bolt on support to cable tray

Install new bolt

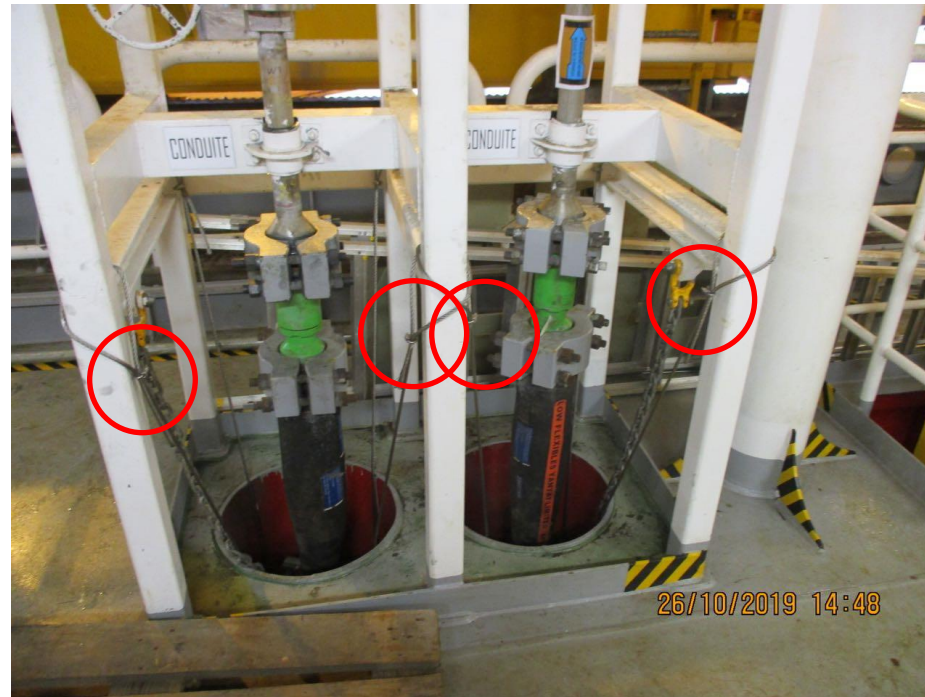
**Finding:** 2.1

**Class:** 4

Moonpool stb fwd, deck level

**Description:** Support wires for hose guide have only one clamp and it's the wrong type.

Fit additional/correct clamps.

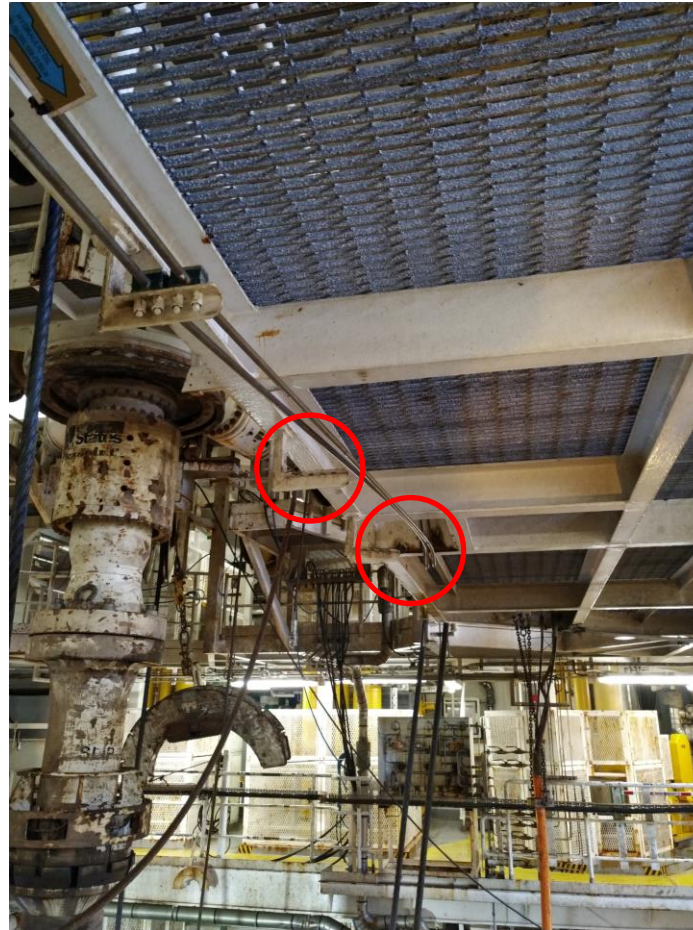
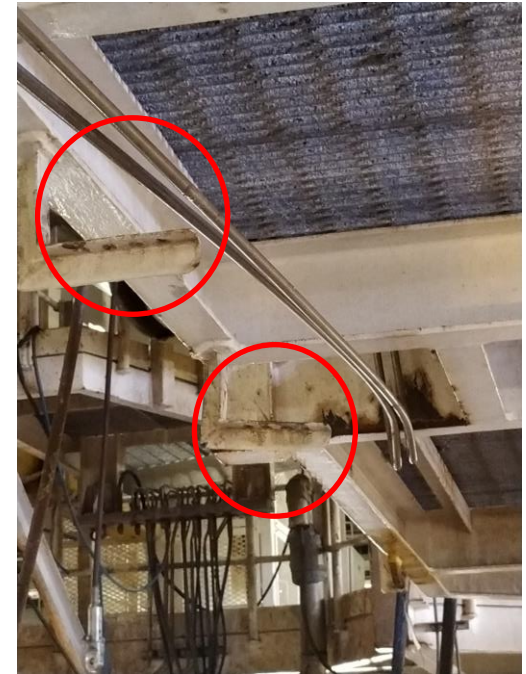
**Finding:** 2.2

**Class:** 4

**Location:**  
Moonpool stbd aft

**Description:** Missing brackets on pipe

**Required action:**  
Install clamps on pipes

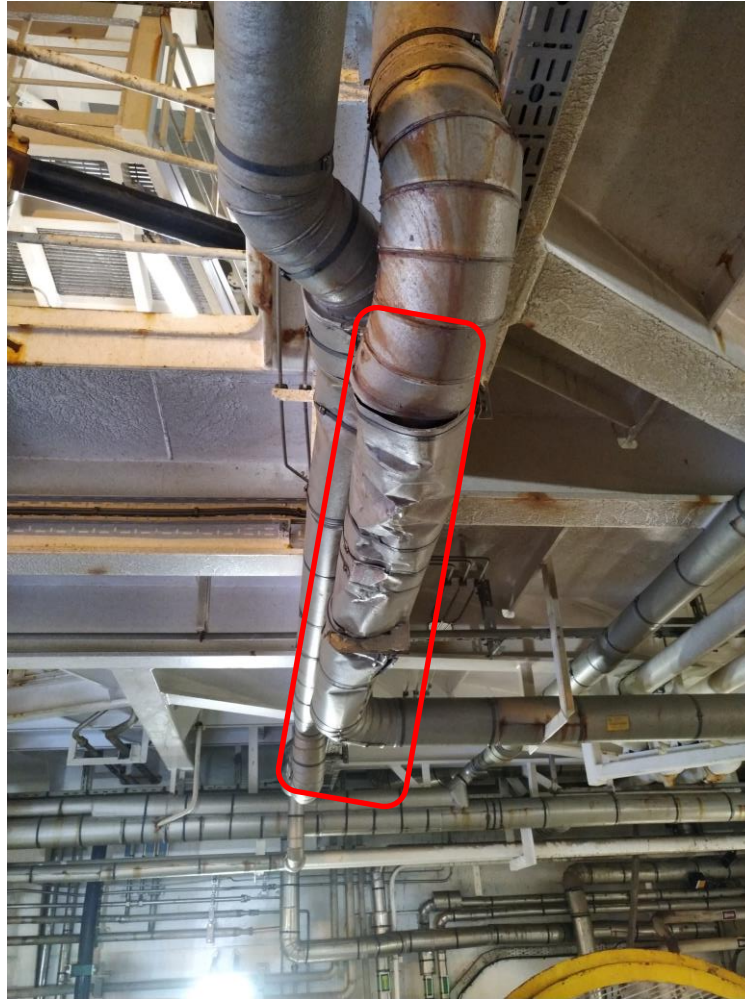
**Finding:** 2.3

**Class:** 4

**Location:**  
Moonpool Port center.

**Description:** Insulation cladding damaged.

**Required action:**  
Recommend to change.

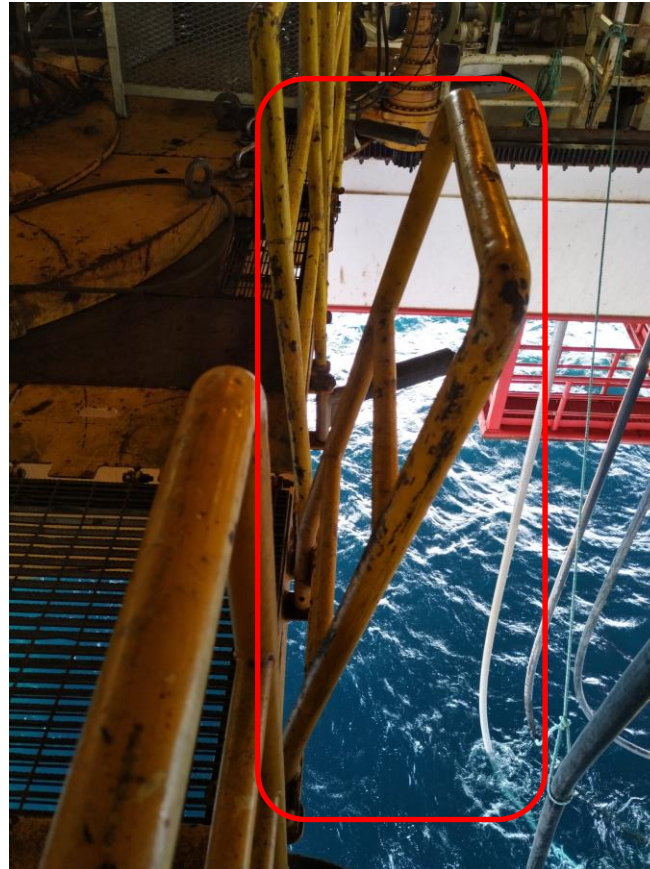
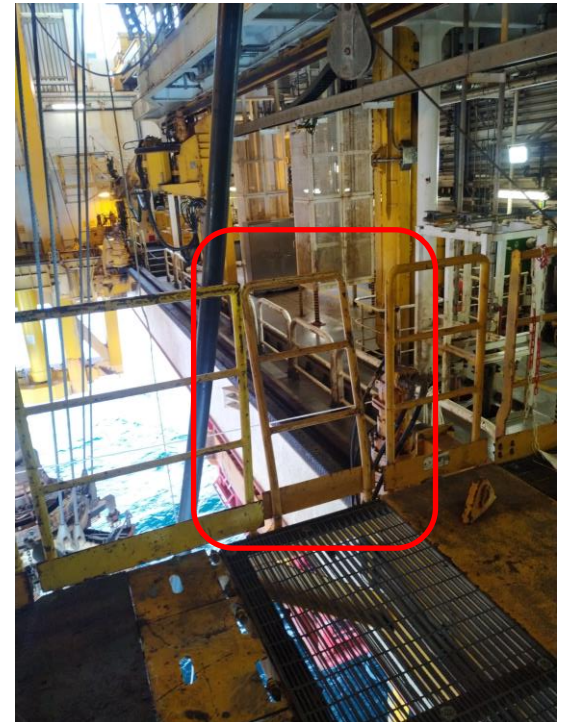
**Finding:** 2.4

**Class:** 2

**Location:**  
Moonpool port skid.

**Description:** Movable railings its damaged and not secured with safety bolt in bracket.

**Required action:**  
Change out damaged railing and secure with bolt.

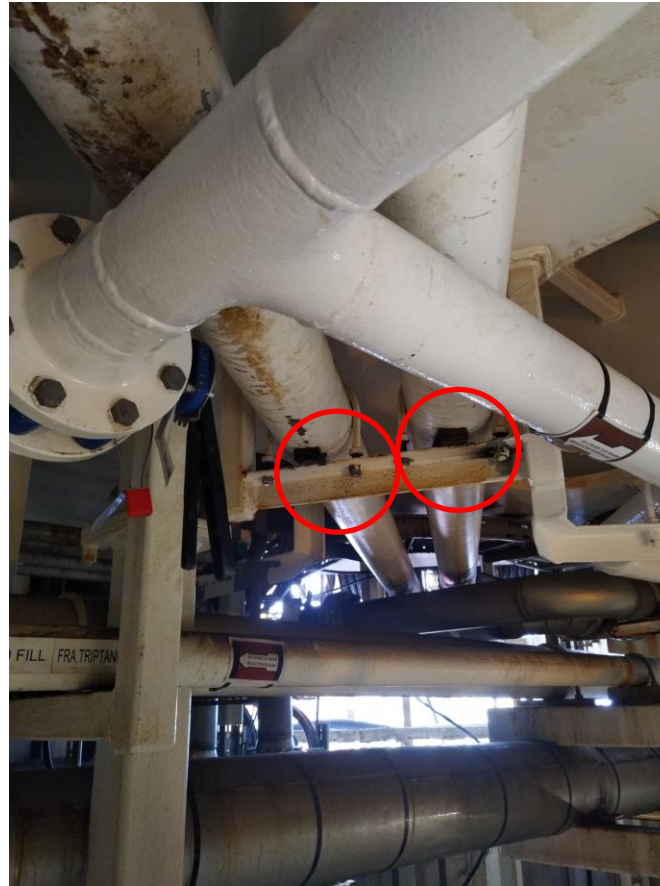
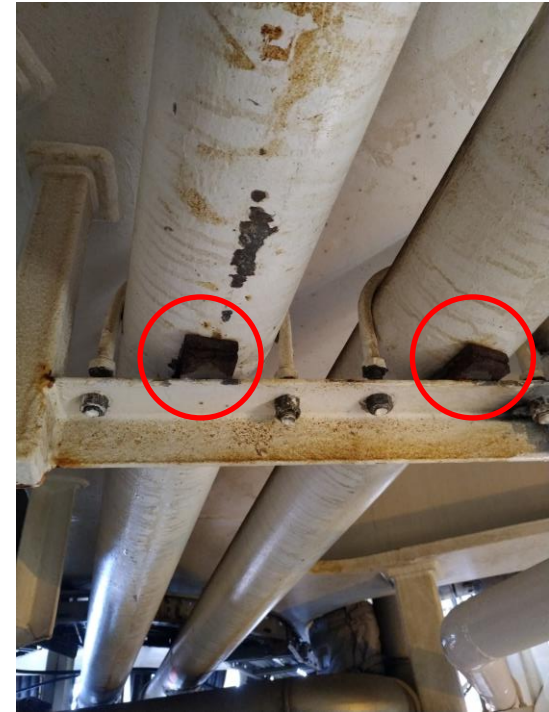
**Finding:** 2.5

**Class:** 4

**Location:**  
Moonpool upper deck port aft.

Steel shims between pipes and support are not secured.

Recommend to secure shims

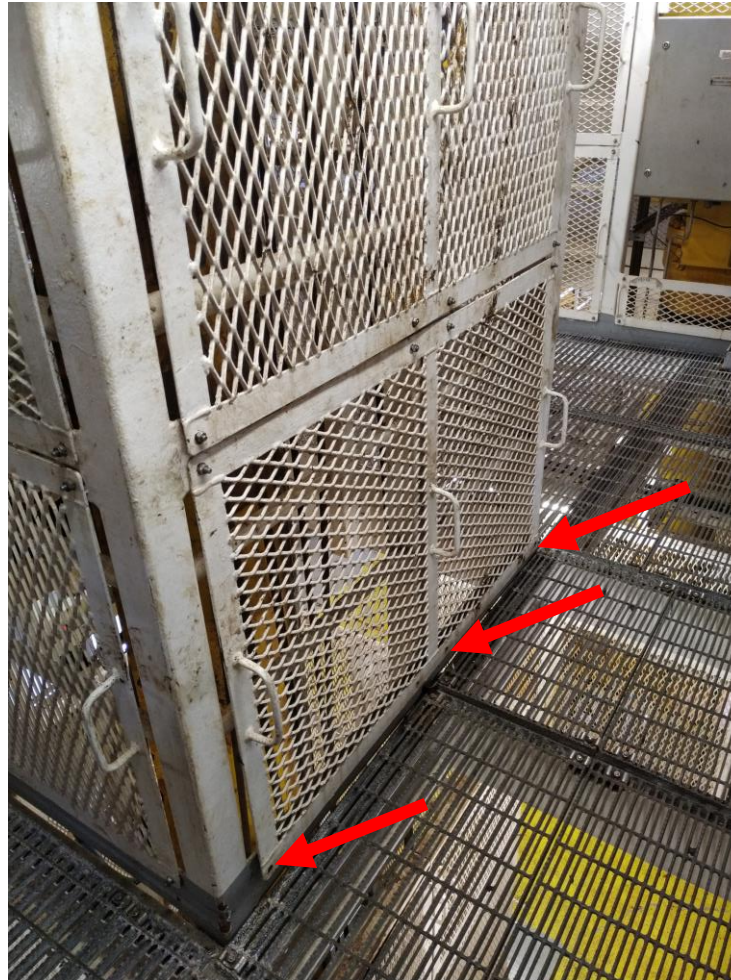
**Finding:** 2.6

**Class:** 4

**Location:**  
Moonpool upper deck port center.

**Description:**  
Missing bolts on wire mesh.

**Required action:**  
Install bolts.

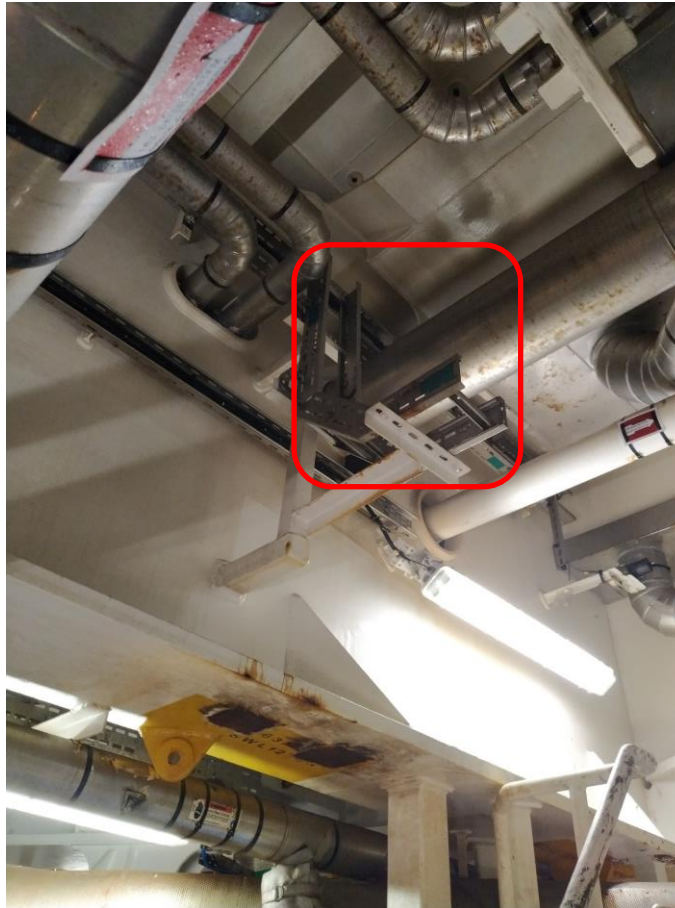
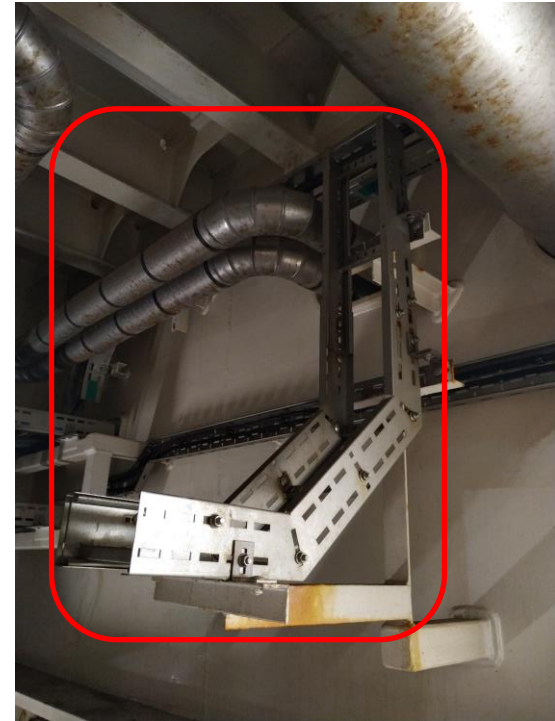
**Finding:** 2.7

**Class:** 4

Moonpool upper deck center

Redundant cable tray.

If not to be used, we recommend to remove all unnecessary equipment in height.

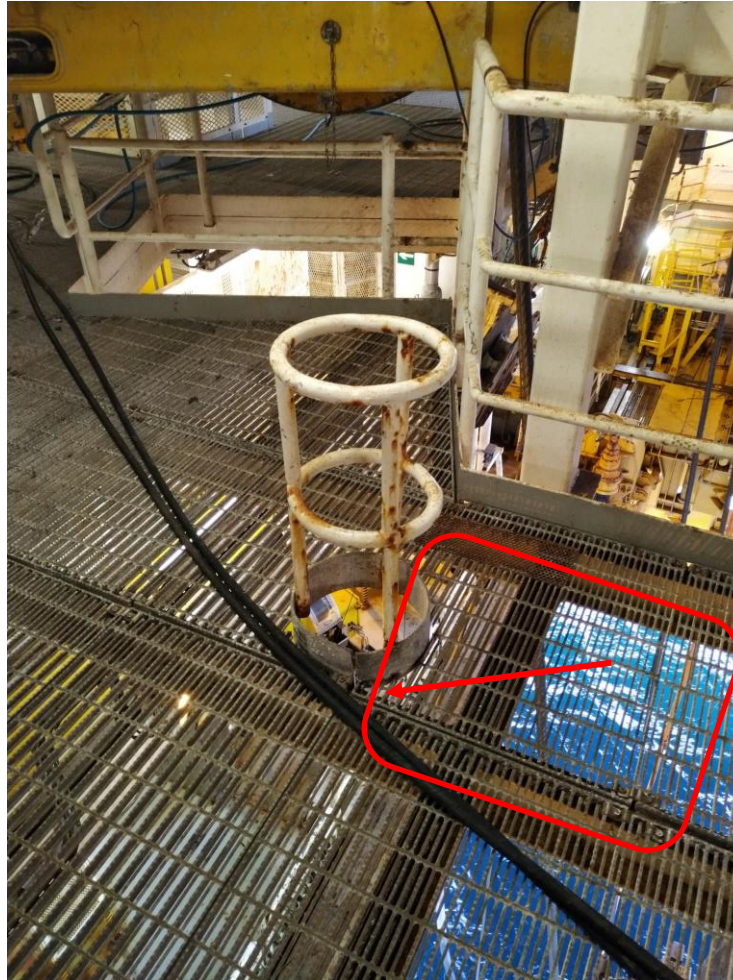
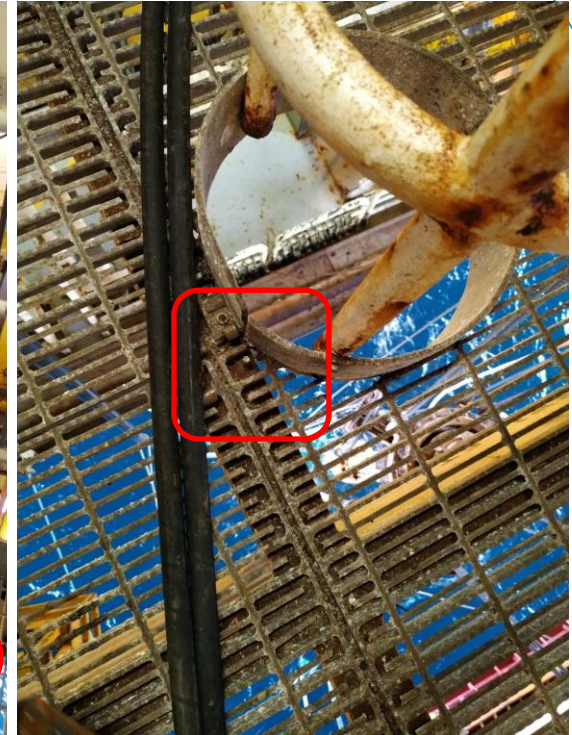
**Finding:** 2.8

**Class:** 4

Moonpool upper deck port center.

Missing grating clips.

Install missing grating clips

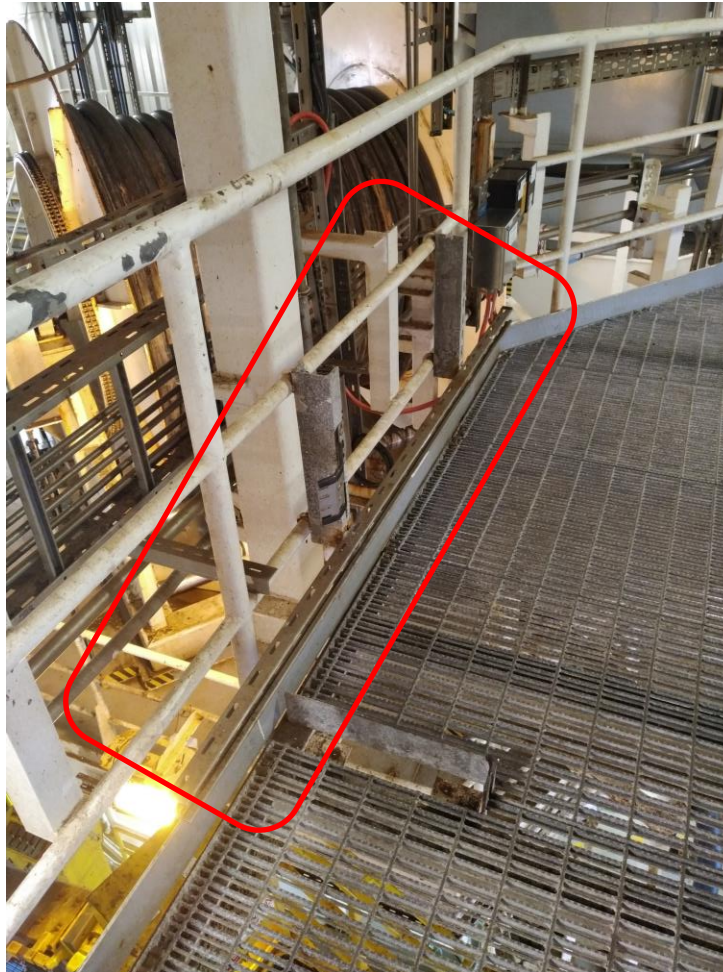
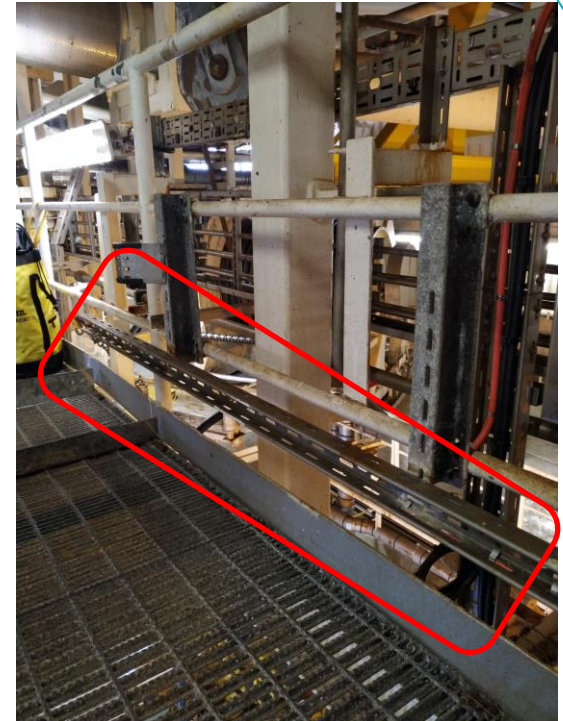
**Finding:** 2.9

**Class:** 4

**Location:**  
Moonpool upper deck port center.

Redundant cable tray.

If not to be used, we recommend to remove all unnecessary equipment in height.

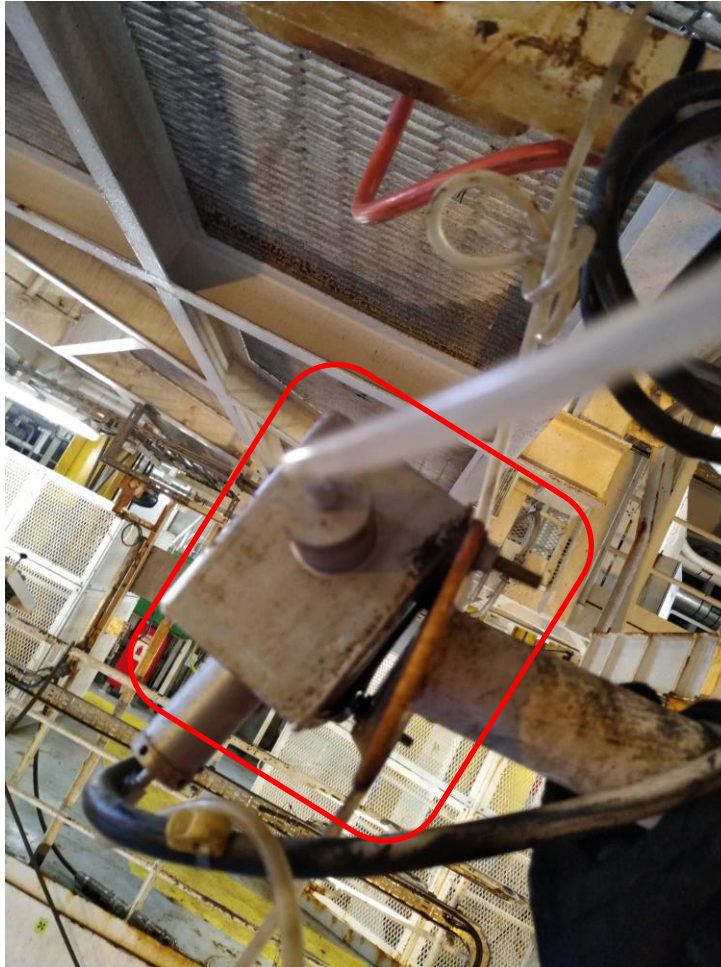
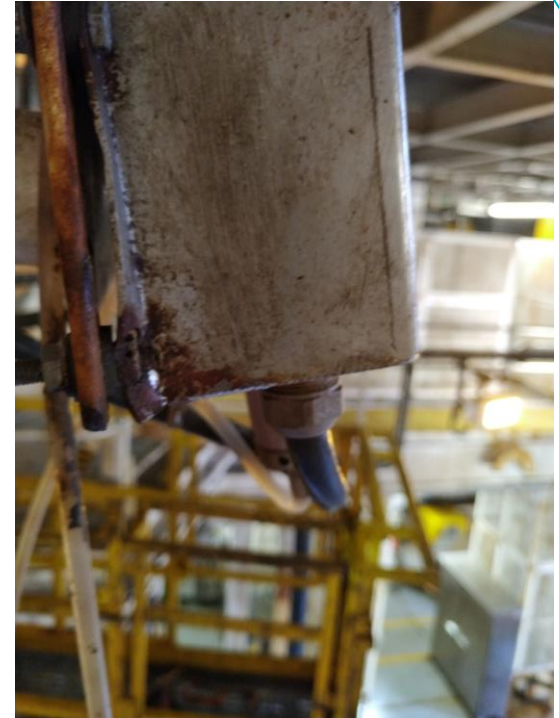
**Finding:** 2.10

**Class:** 3

Moonpool upper deck port center.

Missing bolt on washer fluid tank.

Install missing bolt.

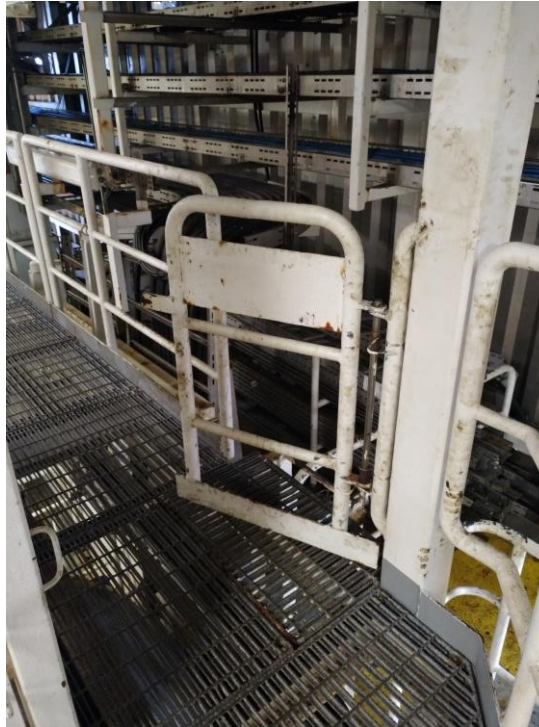
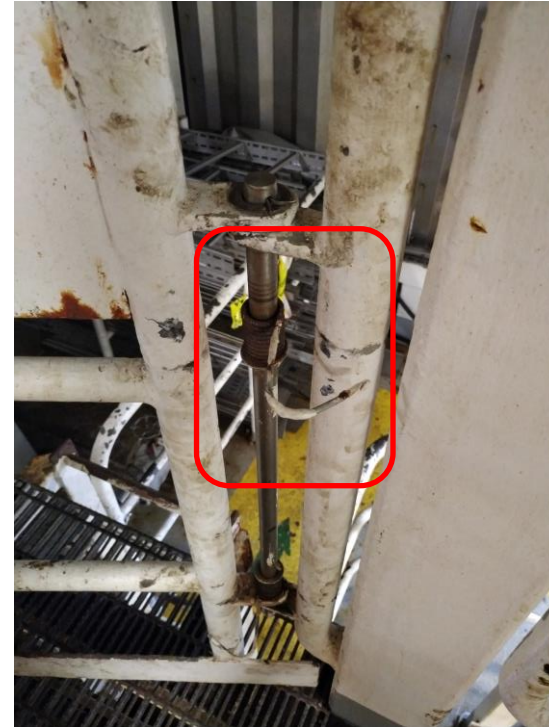
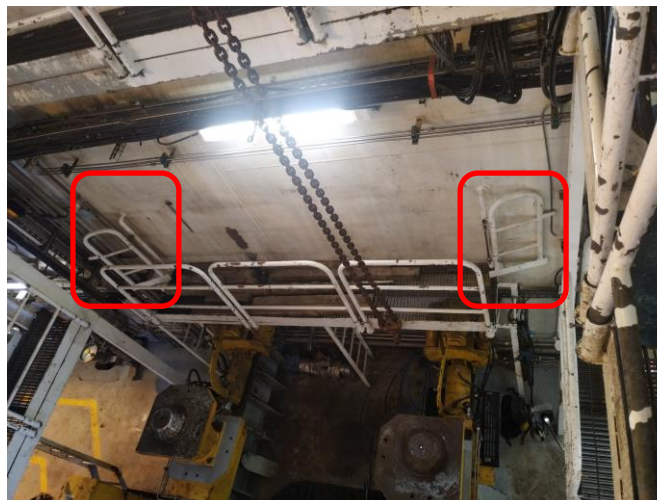
**Finding:** 2.11

**Class:** 4

**Location:**  
Moonpool

3 gates is not self-closing. Spring is broken.

Install new springs.

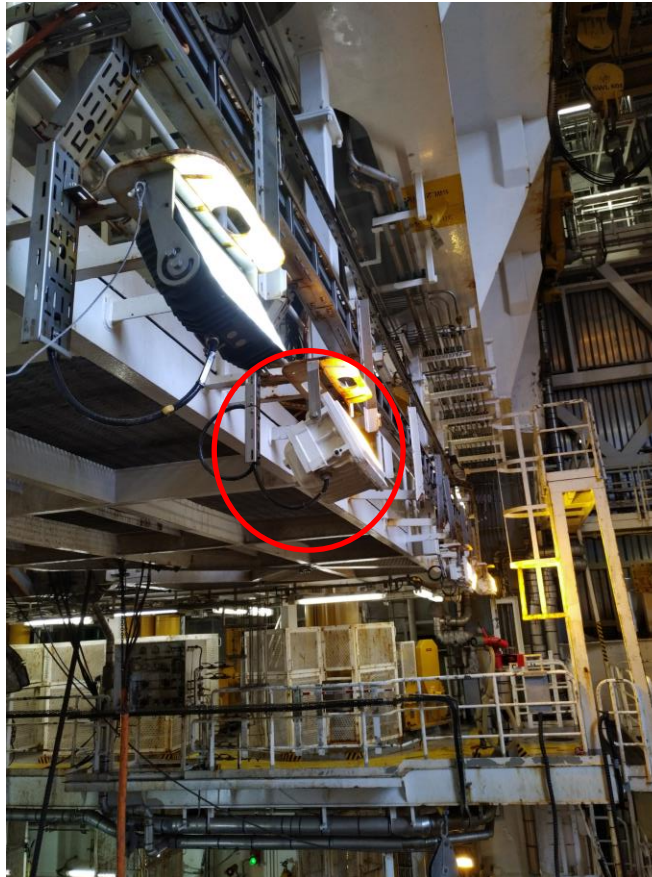
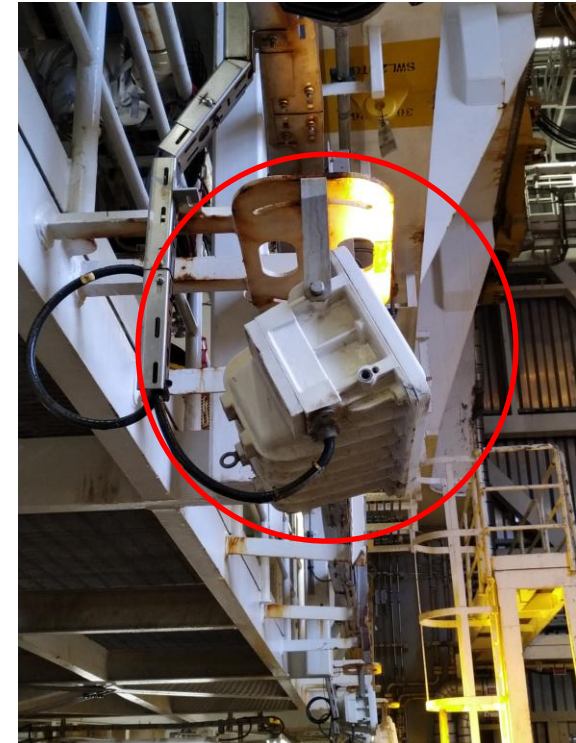
**Finding:** 2.12

**Class:** 4

**Location:**  
Moonpool stbd center.

**Description:** Missing secondary retention

**Required action:**  
Install secondary retention

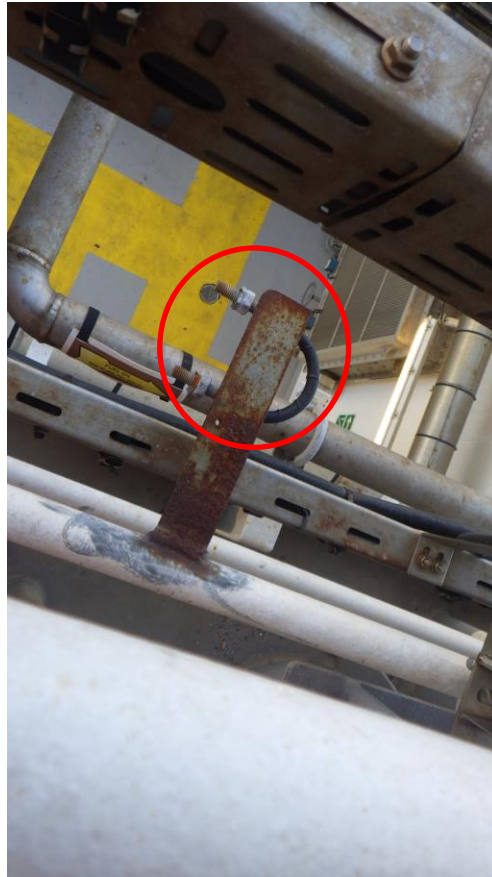
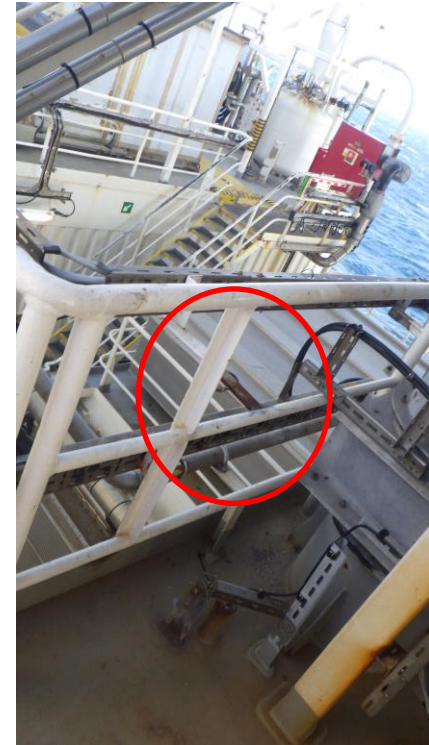
**Finding:** 3.1

**Class:** 4

**Location:**  
living quarters FRW PORT side

**Description:** Redundant brackets

**Required action:** Remove brackets

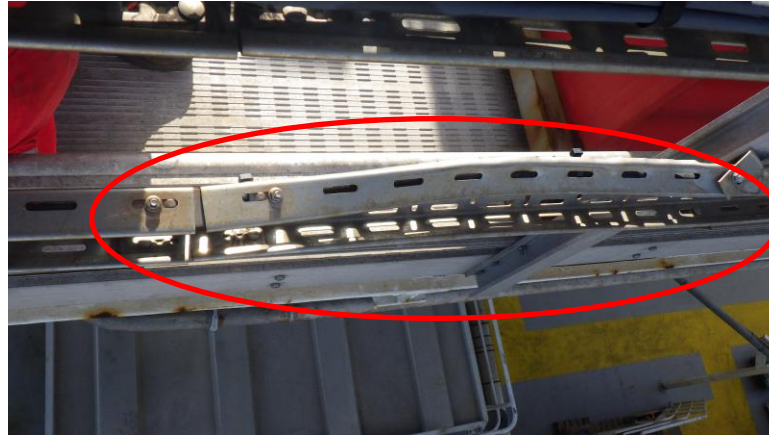
**Finding:** 3.2

**Class:** 4

living quarters FRW PORT side  
helideck

**Description:** Damaged cable tray

**Required action:** Replace cable tray
