# DEEPSEA YANTAI

## DROPS INSPECTION PICTURE LOG

August 2023 | AXESS PROJECT NO 258034-16 | PO: TBA

| Subject:<br>Deepsea Yantai DROPS Inspection Picture log 2023 | | | |

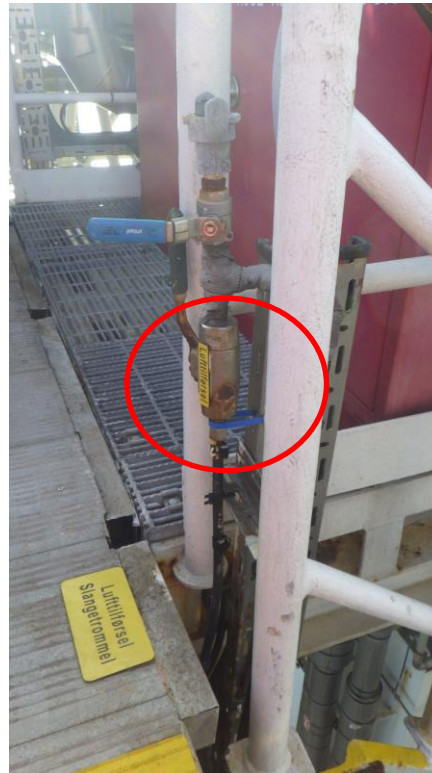
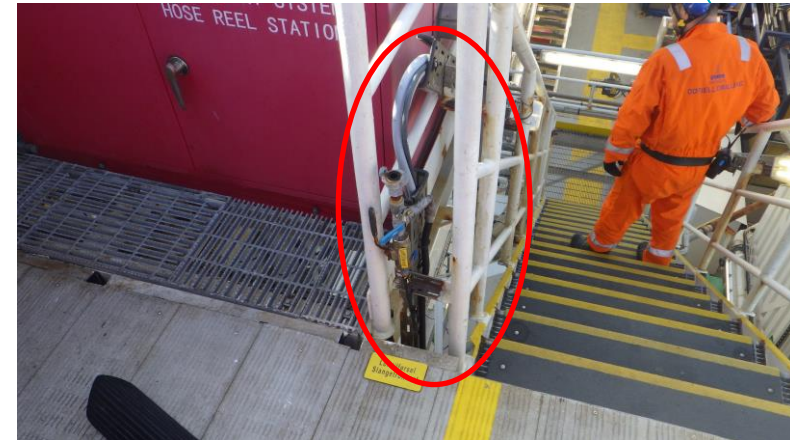
**Finding:** 3.3

**Class:** 4

living quarters FRW PORT side  
helideck

**Description:** Incorrect securing of air  
valve

**Required action:** Install the correct  
fasteners

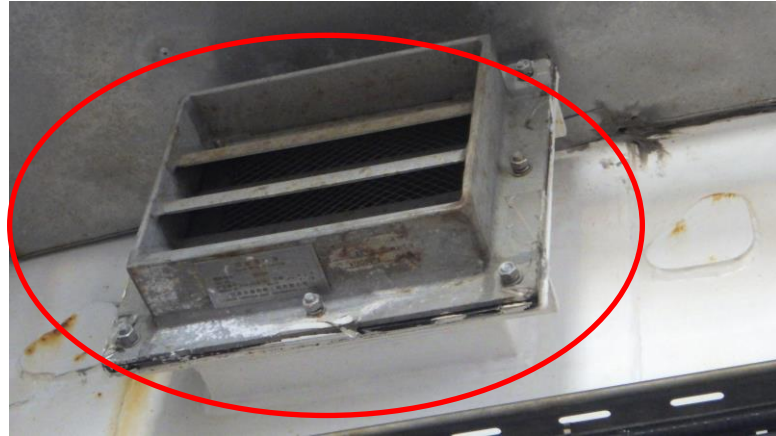
**Finding:** 3.4

**Class:** 4

Living quarters Port fwd

**Description:** Loose bolts on valve

**Required action:** Tighten the bolts

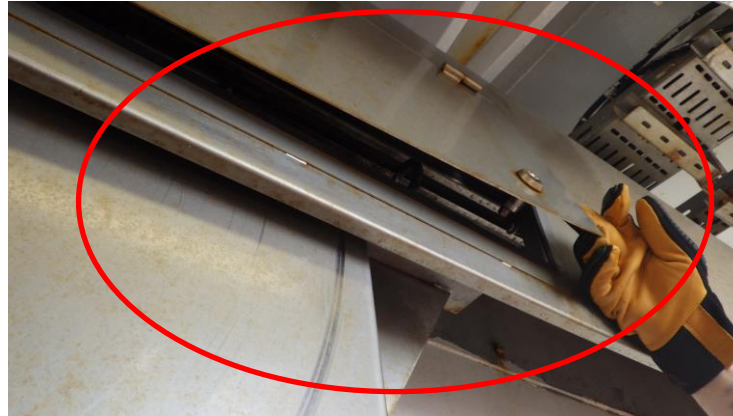
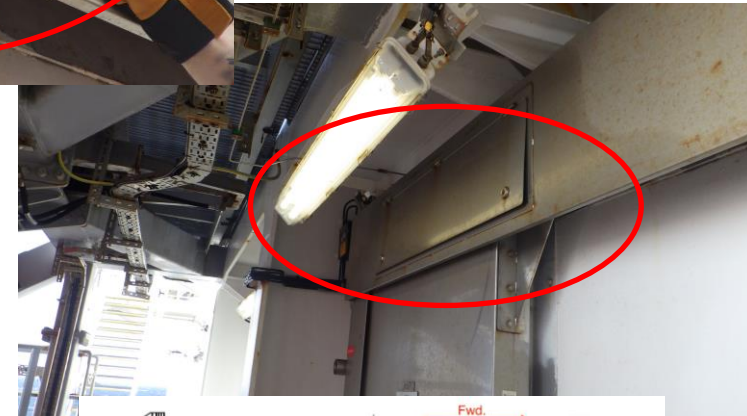
**Finding:** 3.5

**Class:** 4

Living quarters Mid Fwd

**Description:** Broken lock on the maintenance hatch above the pneumatic door

**Required action:** Replace lock

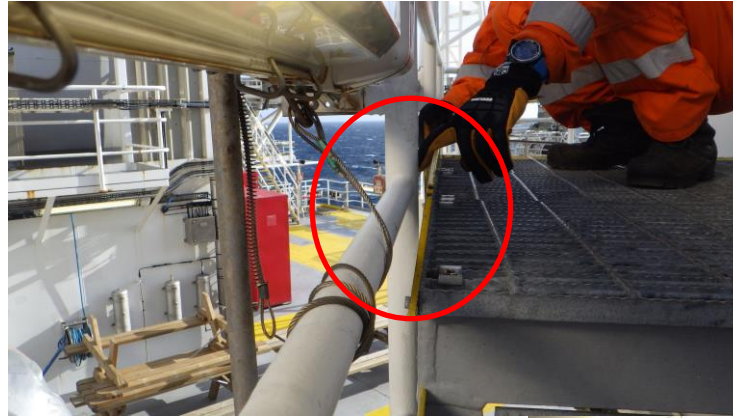
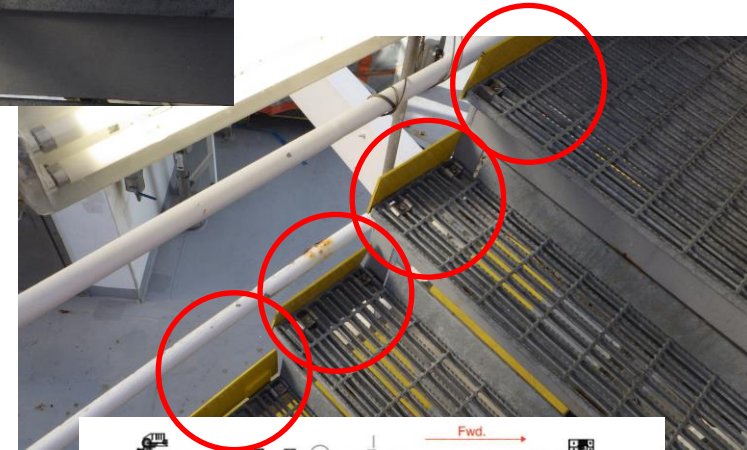
**Finding:** 3.6

**Class:** 2

Living quarters FRW MID

**Description:** Loose skirting on the staircase to the walkway to the bridge port and stb side

**Required action:** Replace bolts on skirtings

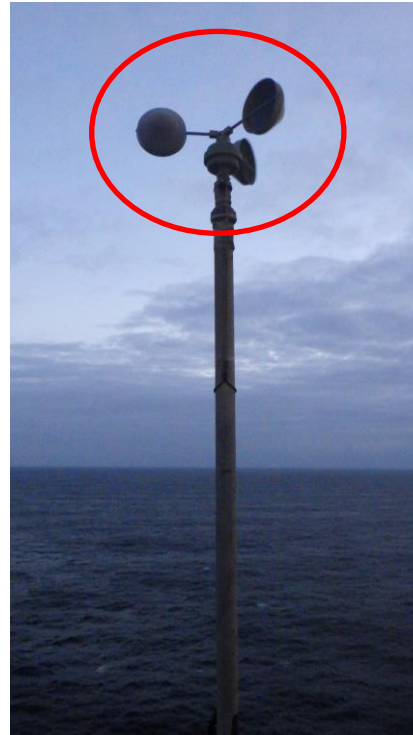
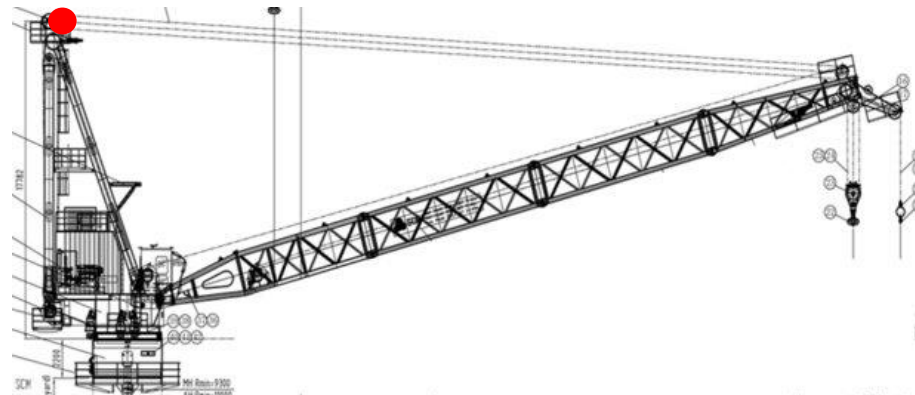
**Finding:** 4.1

**Class:** 4

**Location:**  
STB offshore crane

**Description:** Wind sensor with moving parts should be replaced with an ultrasonic sensor

**Required action:** Replace with ultrasonic sensor

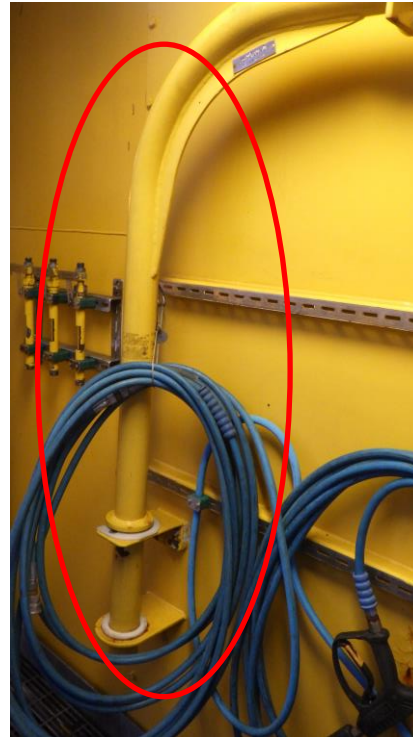
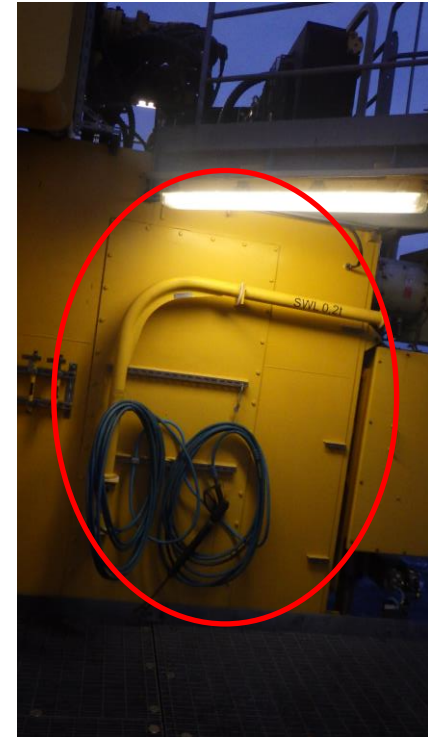
**Finding:** 4.2

**Class:** 4

**Location:**  
STB offshore crane

**Description:** Loose swing beam has no secondary retention

**Required action:** Install secondary retention

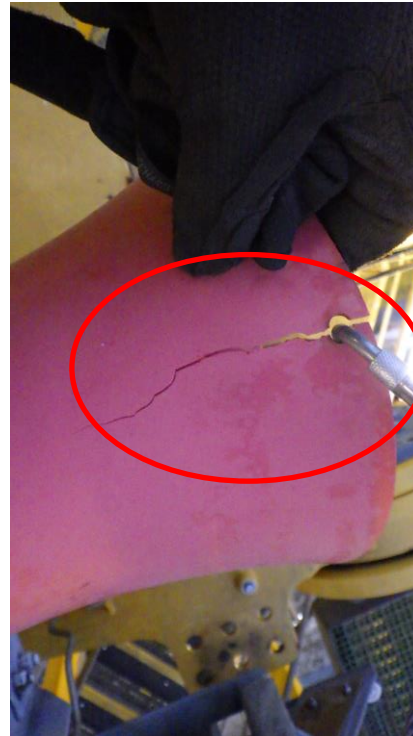
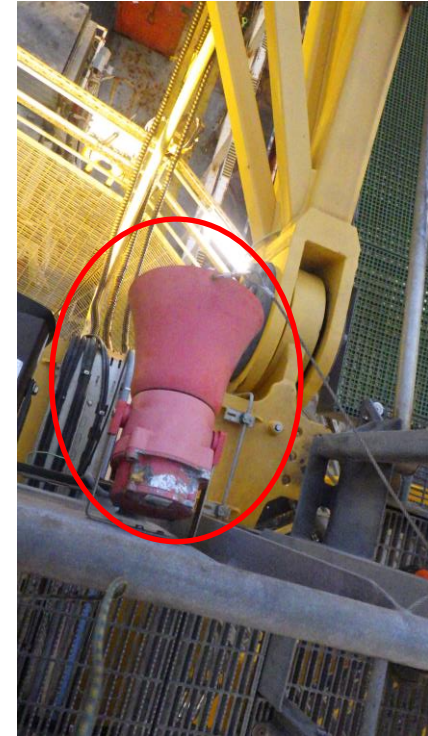
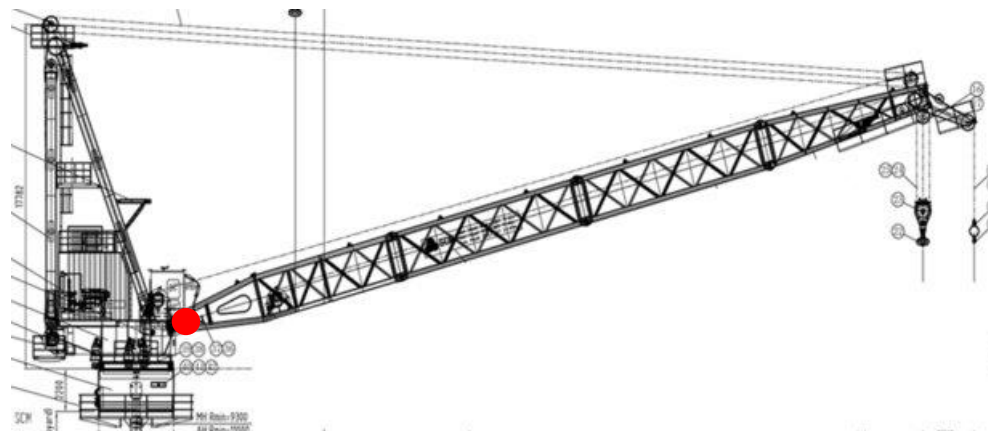
**Finding:** 4.3

**Class:** 3

**Location:**  
STB offshore crane

**Description:** The plastic for the foghorn is broken which makes the secondary retention not active

**Required action:** Install new foghorn

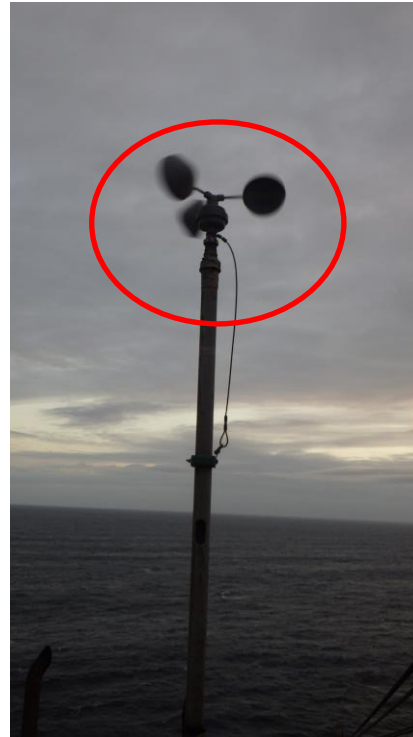
**Finding:** 5.1

**Class:** 4

**Location:**  
PORT offshore crane

**Description:** Wind sensor with moving parts should be replaced with an ultrasonic sensor

**Required action:** Replace with ultrasonic sensor

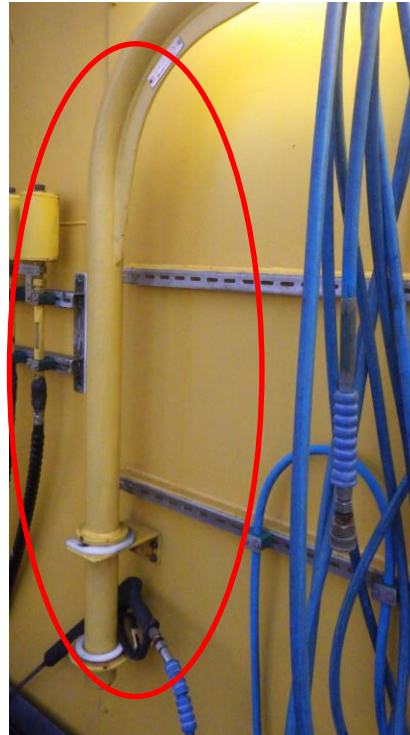
**Finding:** 5.2

**Class:** 4

**Location:**  
PORT offshore crane

**Description:** Loose swing beam has no secondary retention

**Required action:** Install secondary retention

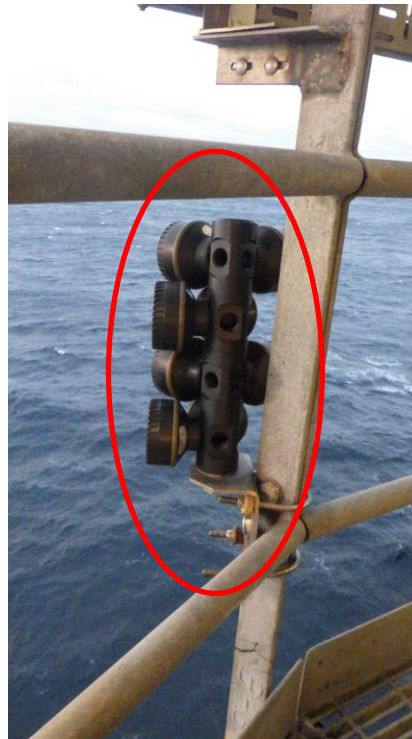
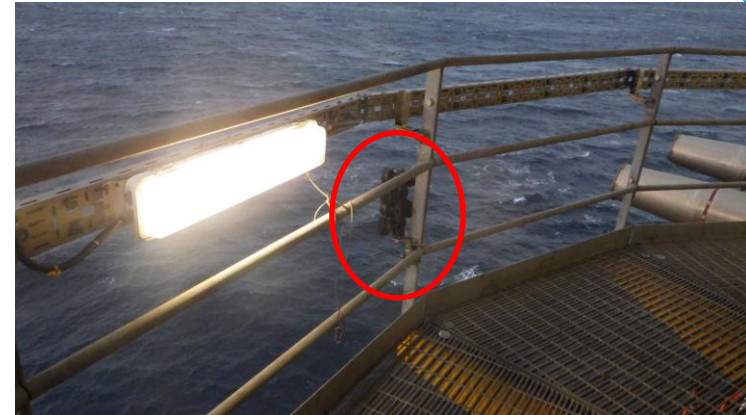
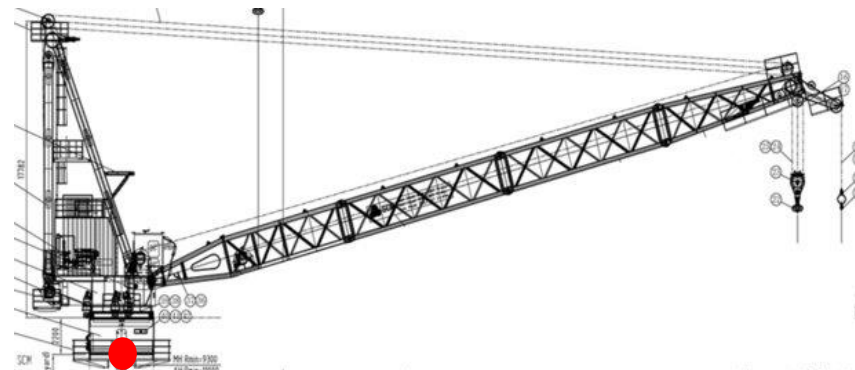
**Finding:** 5.3

**Class:** 4

**Location:**  
PORT offshore crane

**Description:** Equipment at height  
without secondary retention

**Required action:** Install secondary  
retention

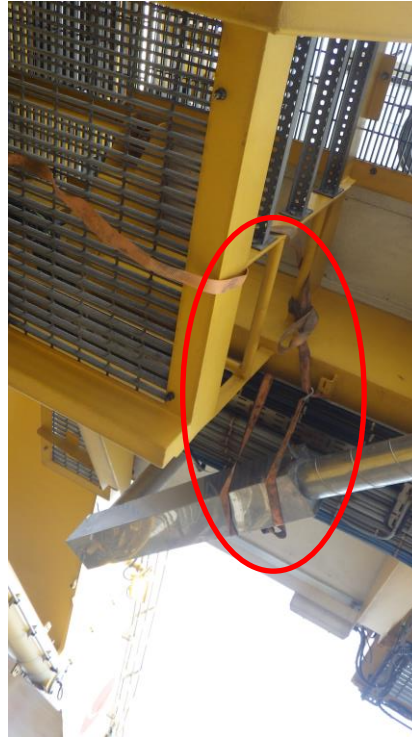
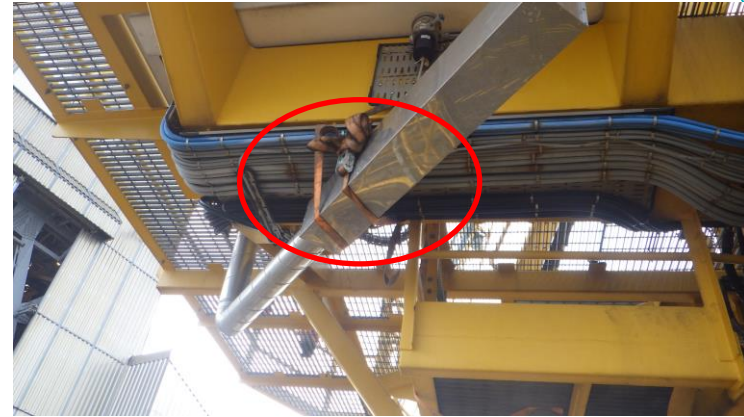
**Finding:** 6.1

**Class:** 4

**Location:**  
PORT offshore crane

**Description:** Equipment at height secured with jack strap

**Required action:** Fit the correct attachment point and remove the jack strap

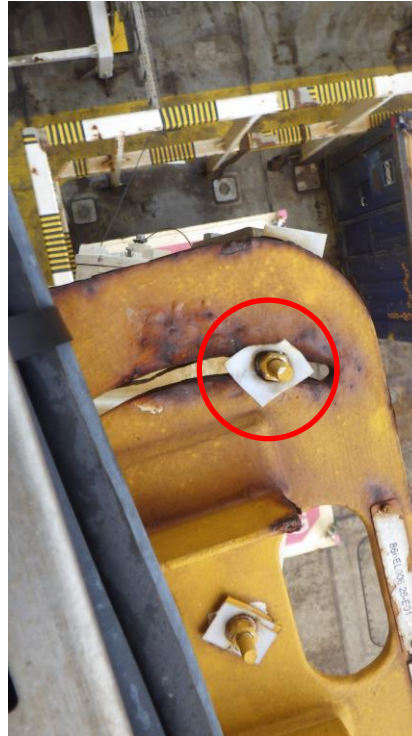
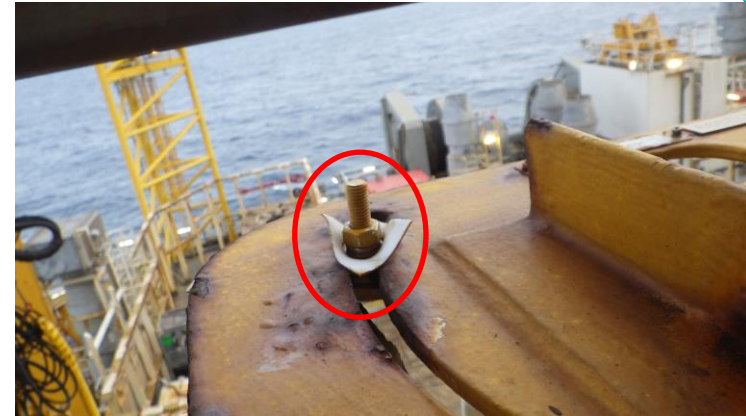
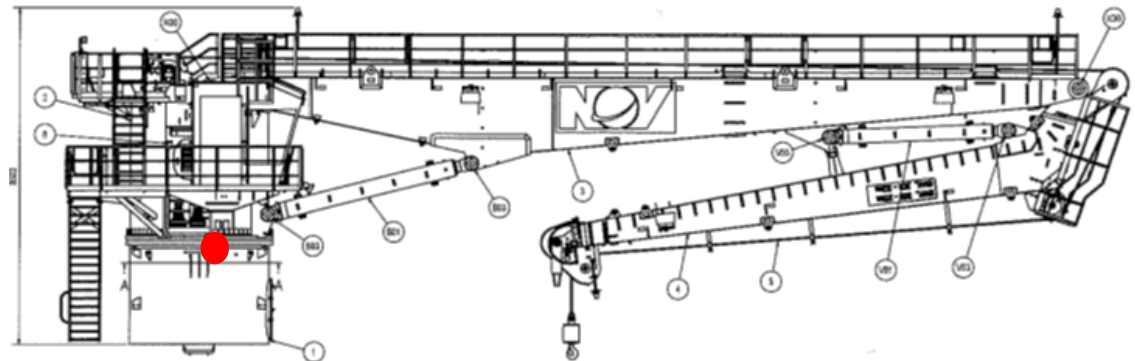
**Finding:** 6.2

**Class:** 4

**Location:**  
PORT offshore crane

**Description:** Washer used for bolt is too small

**Required action:** Remove old washer and apply correct size washer
