# DEEPSEA YANTAI

## DROPS INSPECTION PICTURE LOG

August 2023 | AXESS PROJECT NO 258034-16 | PO: TBA

| Subject:<br>Deepsea Yantai DROPS Inspection Picture log 2023 | | | |

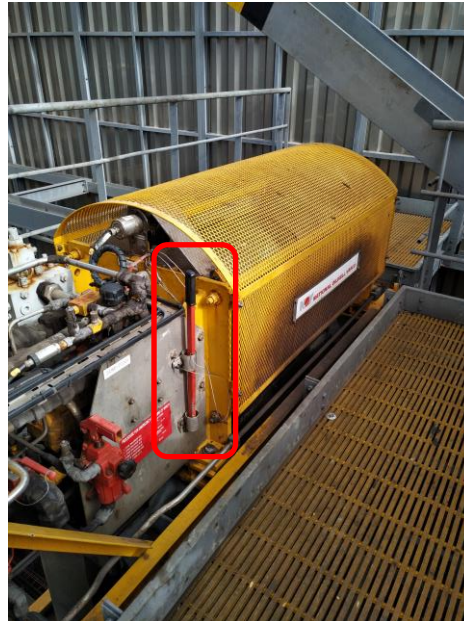
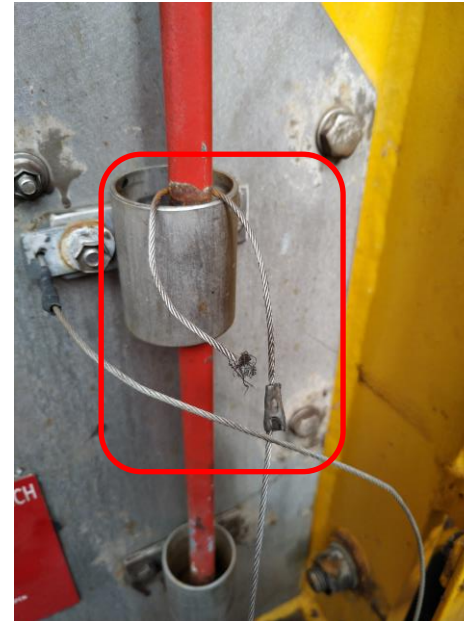
**Finding:** 1.5

Derrick. Stand building winch

Broken securing on handle for emergency lowering.

CLOSED  
FINDING

Install securing on handle

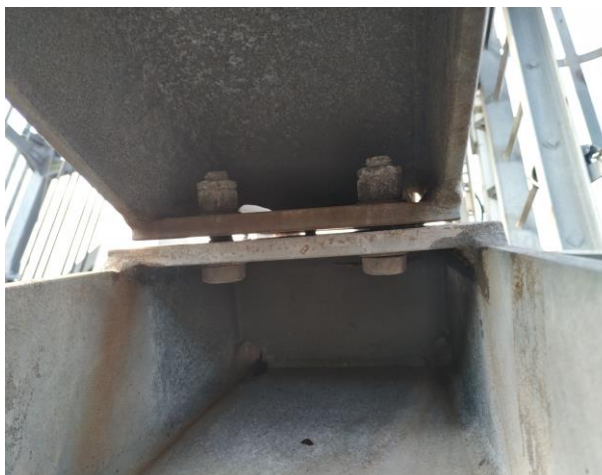
**Finding:** 1.7

Loose bolts on wind walls behind door for moonpool and on aft side of door.
